# **ACCOTINK CREEK STREAM STABILITY ASSESSMENT AND PRIORITIZATION PLAN**

## **SUPPLEMENTAL REPORT FOR DANIELS RUN**

**City of Fairfax, Virginia**

**October 14, 2008**

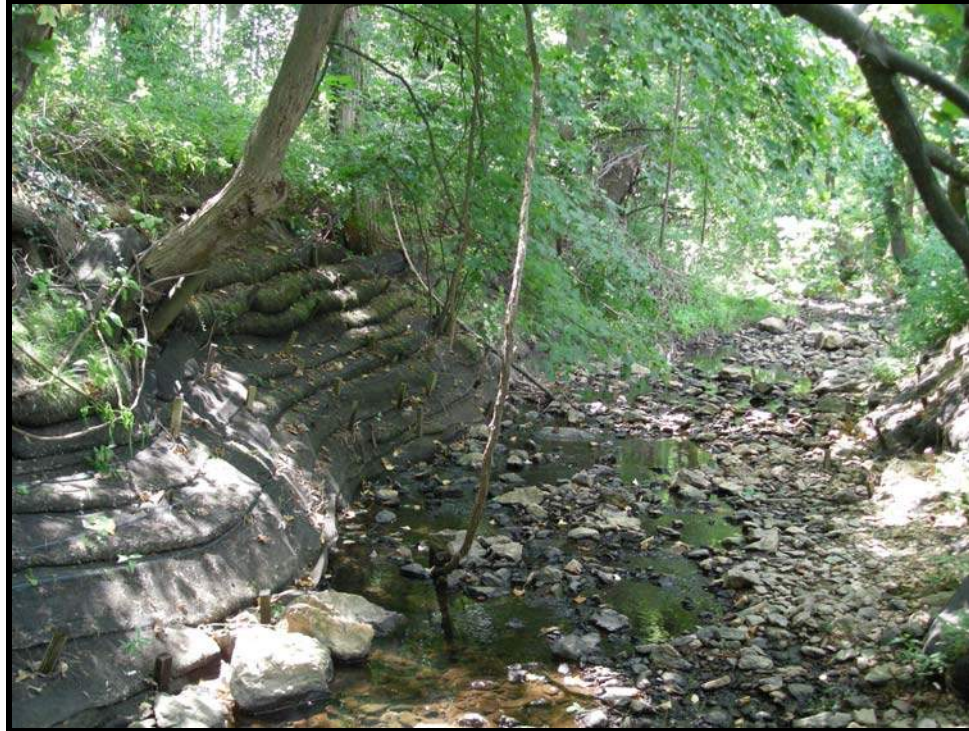
**Figure 5: Filtrex Socks at Daniels Run**

As Figure 5 illustrates, plantings have not become fully established, although many of the tubes are still stable and in place. This area (D1-009 and D1-010) can be stabilized by identifying areas of local destabilization and a comprehensive planting plan to reinforce the Filtrexx systems already in place. This area requires light restoration. Portions of D1-010 have been previously stabilized (near a pedestrian bridge). This reach is experiencing severe bank erosion, as is evident in the near-vertical 5-6 foot high banks, and will require a greater effort than D1-009. Moderate restoration should be assumed for this area. Any work done in these reaches should incorporate public educational components and be integrated into the restoration work performed previously on school grounds.

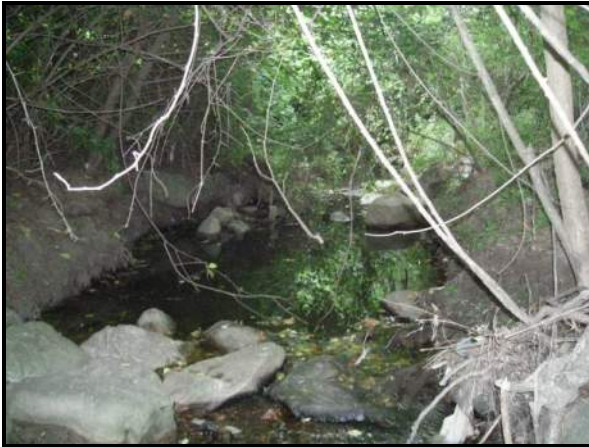
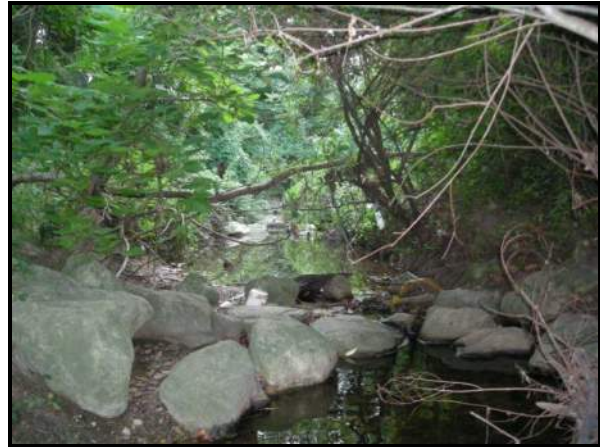
**Site Score:** 33.2 – High

**Site Description:** Reach Length = 888 LF

Reach primarily seems to be in park area, with a pedestrian path approximately 80 feet away. Completely overgrown, but similar to DM-16. Banks 45 degree angle and 3 feet high. Armoring present; when missing, the banks are eroded.

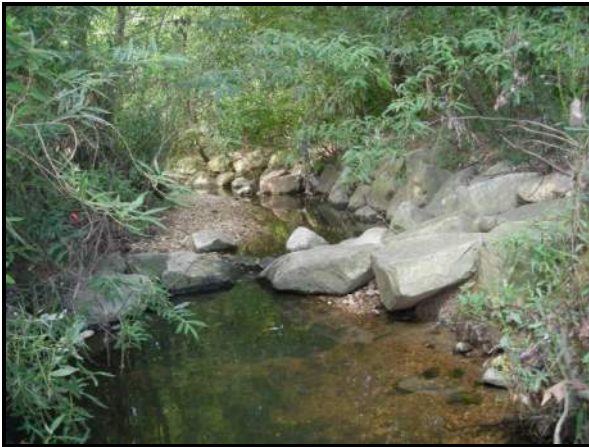
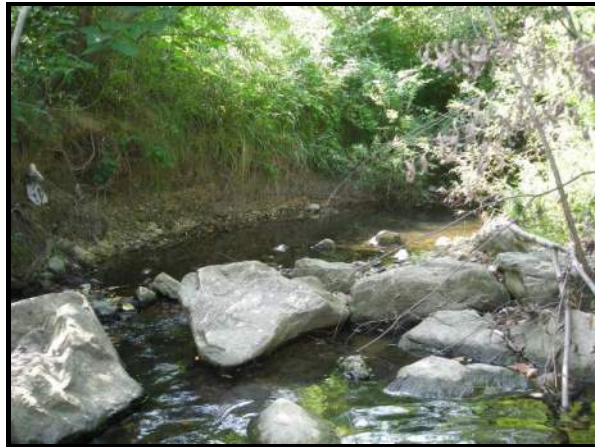
**Site Score:** 30.3 – High

**Site Description:** Reach Length = 1033 LF

Just downstream of pond above Farrcroft Dr. Completely armored and replanted section of stream. One or two eroded banks where there is no rip rap, but mostly in good condition. Lots of pool features created. 45 degree banks that are 3 feet tall.

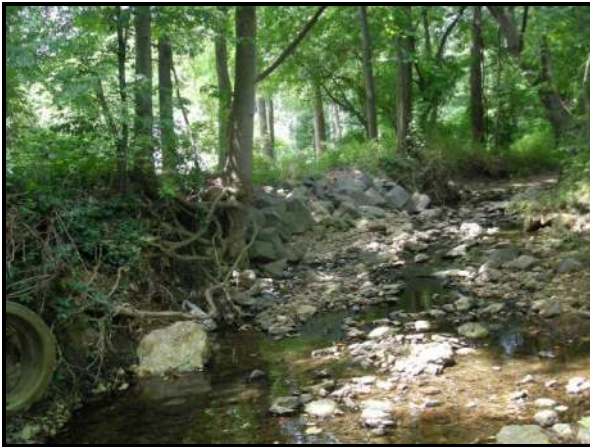
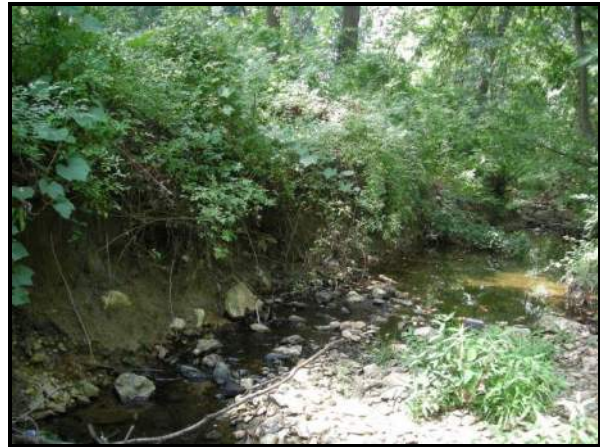
**Site Score:** 41.1 – Very High

**Site Description:** Reach Length = 881 LF

Lots of crawling vines; few trees. Steep, muddy banks. Minor armoring visible, but stream condition poor. Lots of erosion underneath vines.

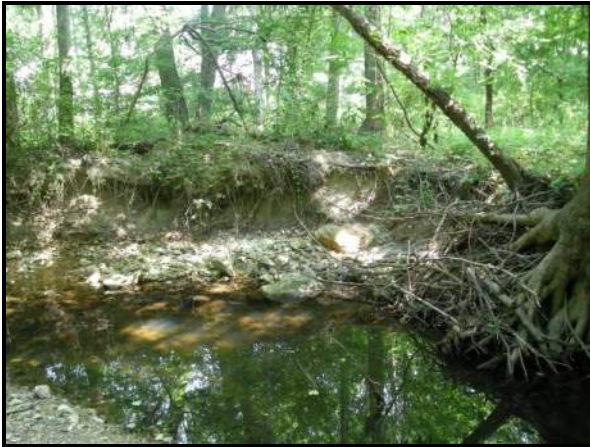
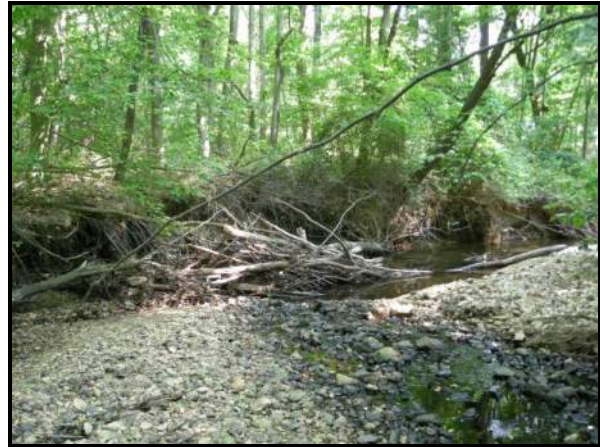
**Site Score:** 48.2 – Extreme

**Site Description:** Reach Length = 377 LF

Lots of fallen trees and erosion. Poor condition, but wider, less sinuous, and smaller banks than DM 4.

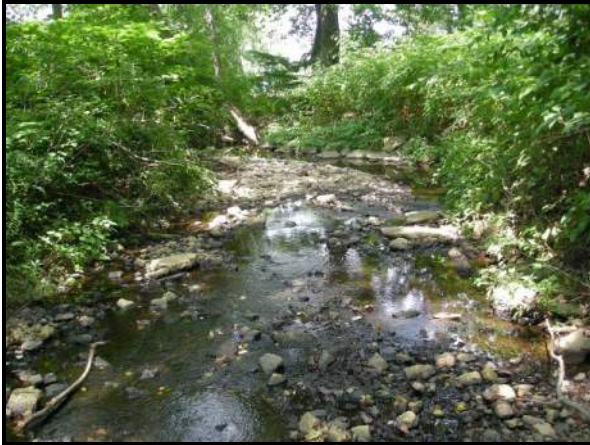
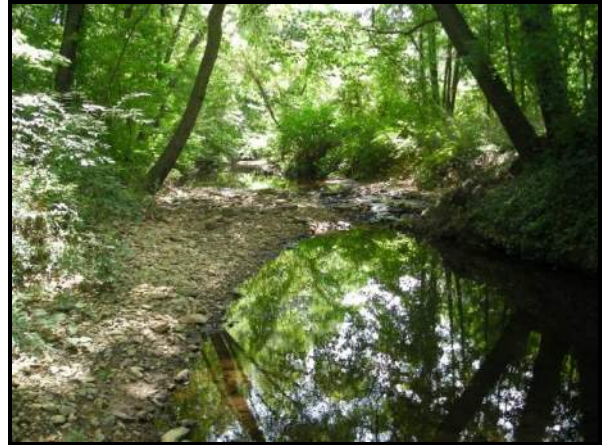
**Site Score:** 28.2 – Moderate

**Site Description:** Reach Length = 685 LF

Excellent condition. Wide, lots of cobble in stream. Some erosion, but not much. Little riprap, big cobble, some fines.

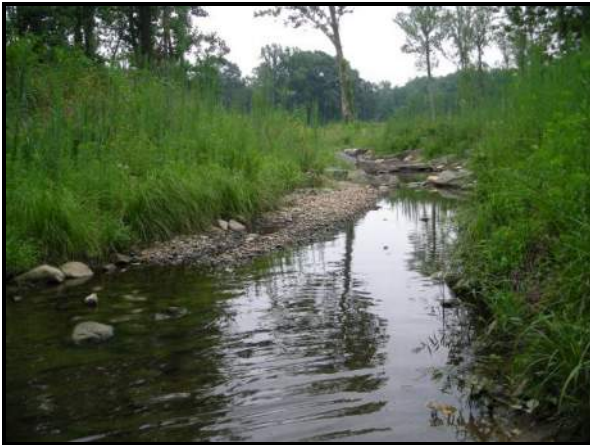
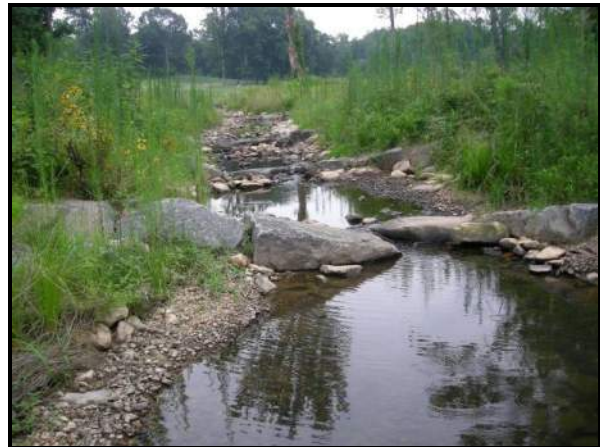
**Site Score:** 29.4 – Moderate

**Site Description:** Reach Length = 239 LF

Excellent condition. Relatively wide, lots of cobble in stream.  
Designed and stabilized recently. Lots of vegetation.

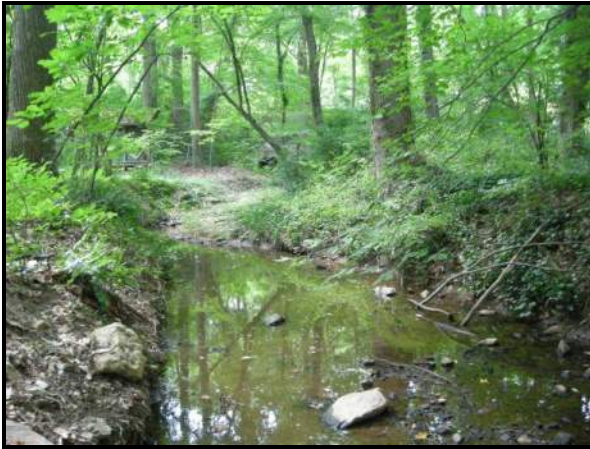
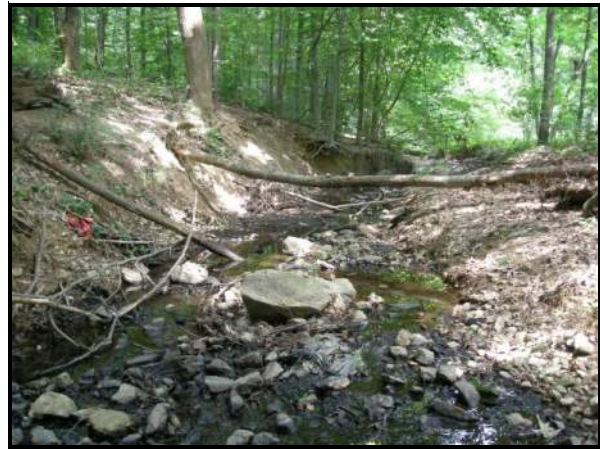
**Site Score:** 40.9 – Very High

**Site Description:** Reach Length = 293 LF

Armored ponded area right after culvert from Ashby Rd. Stream with slightly eroded banks. Bank angle 10 degrees on inside bend and 60 degrees on outside bend- slightly cut banks alongside deposits. One bad area found, but not typical. Some fallen trees.
