# **ACCOTINK CREEK STREAM STABILITY ASSESSMENT AND PRIORITIZATION PLAN**

## **SUPPLEMENTAL REPORT FOR DANIELS RUN**

**City of Fairfax, Virginia**

**October 14, 2008**

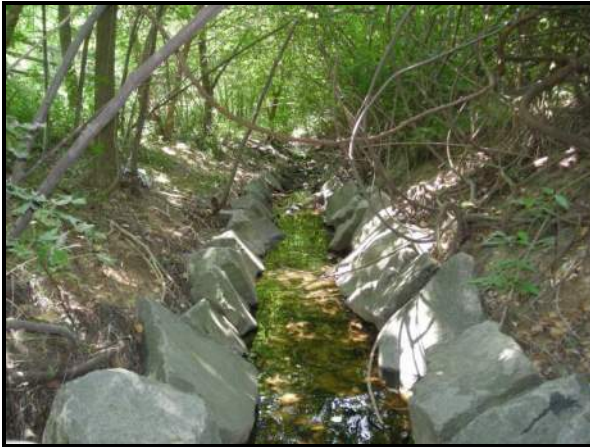
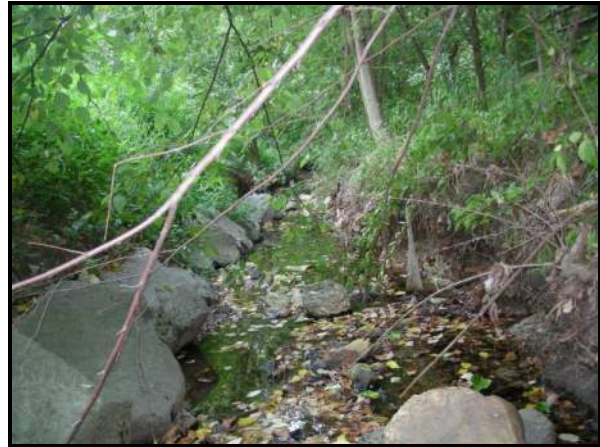
**Location:** Courthouse Drive; from Courthouse Dr. & Ratcliff Rd. to south of Breckinridge Ln.

**Site Score:** 33.2 – High

Located between two residential developments (townhouses). Slightly armored. Where rip rap is in place, stream is fine. Where rip rap is absent, banks eroded and beginning to undercut. Banks steep and vegetated.

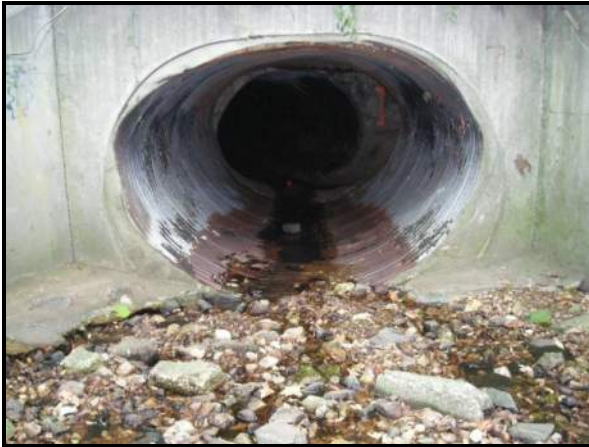
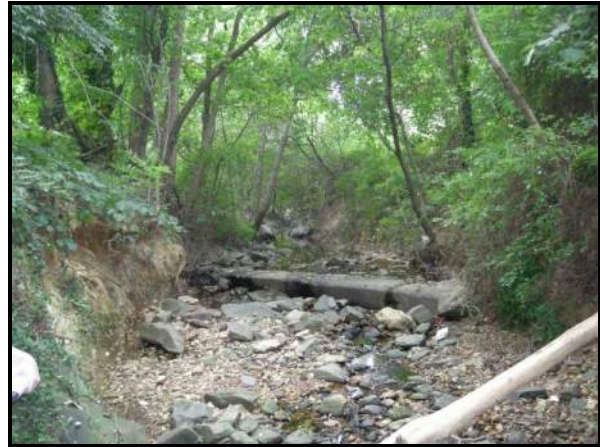
**Location:** Breckinridge Lane; from 130 feet south of Breckinridge Ln. to Breckinridge Ln.

**Site Score:** 50.3 – Extreme

Reach begins near Breckinridge Road. This is 130 feet of wide and high banks before becoming channelized in Reach DM 21. Highly eroded, extreme bank angle, and some vegetation.

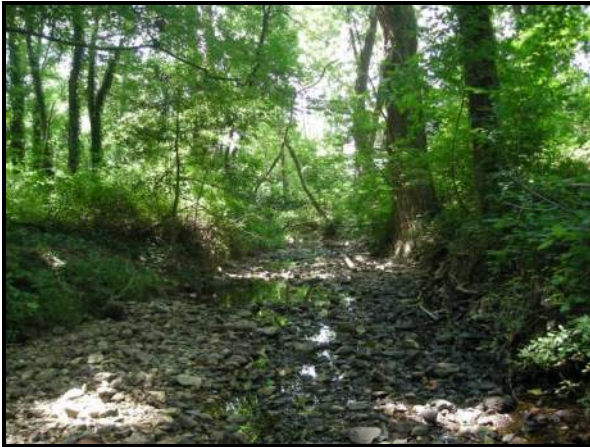
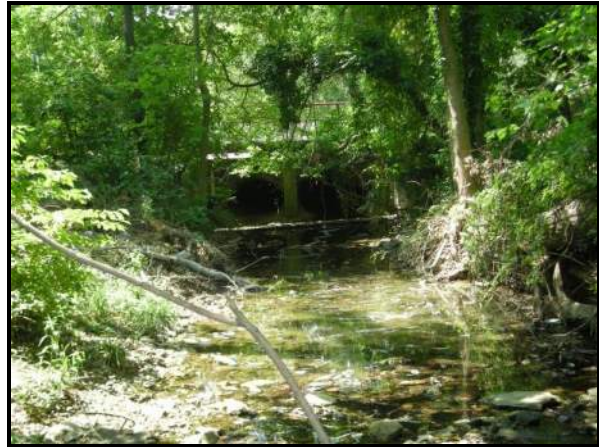
**Location:** South Sager and Main; upstream of Sager Ave to approximately 100 ft south of Main St.

**Site Score:** 28.0 – Moderate

Slightly eroded, but smaller bank height and less steep slopes than DM-18. Good amount of vegetation, but mostly vines and trees.

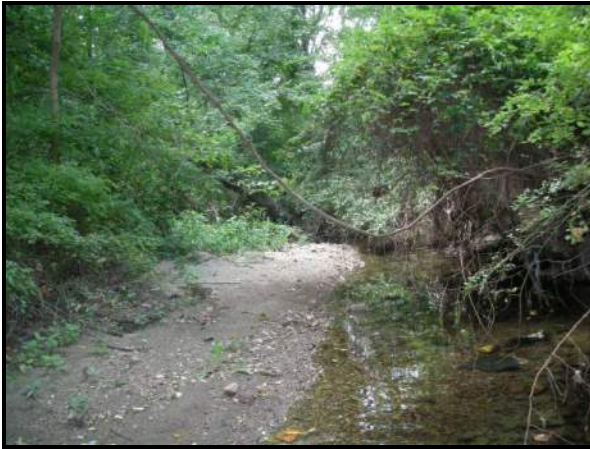
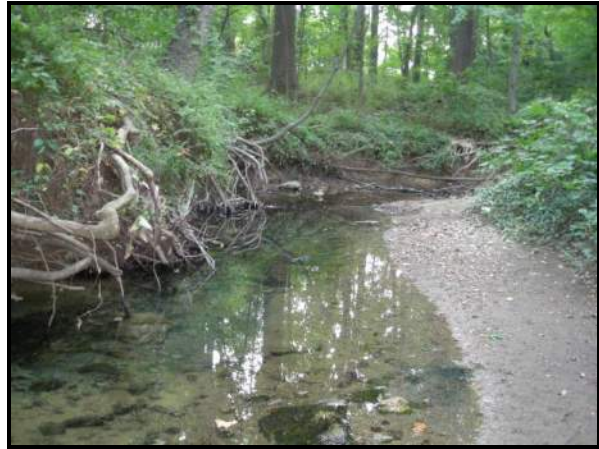
**Location:** North Sager and Main; from 100 ft. south of Main St. to Main St.

**Site Score:** 39.5 – High

The area is just south of Main St. and is highly eroded. The banks are steep and high, though vegetated. No evidence of armoring and trees falling into the stream.

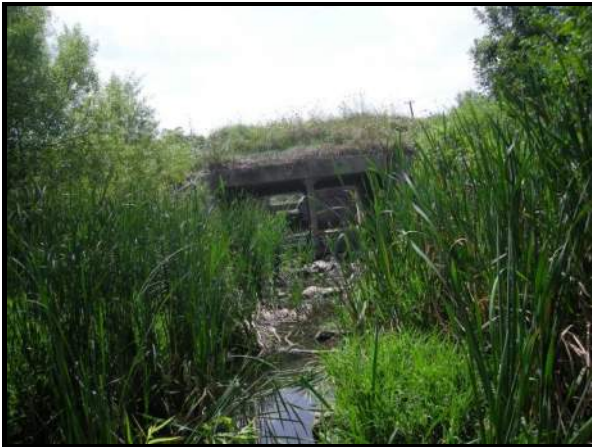
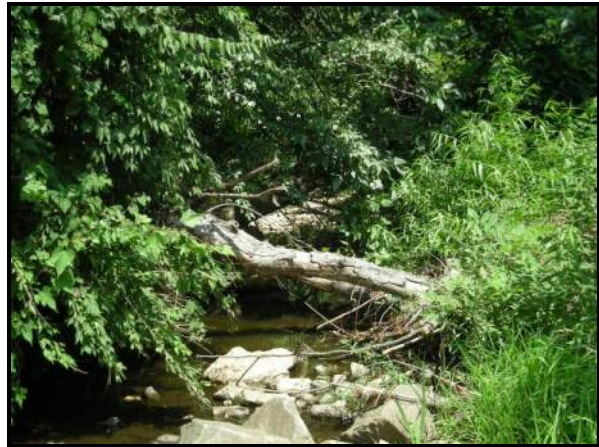
**Location:** North of Farrcroft Drive; from the pond at Farrcroft Dr. to approximately 100 ft northeast

**Site Score:** 27.2 – Moderate

Open area right before stream feeds into pond; two reaches separated by fallen trees. Lots of vegetation, rip rap present.

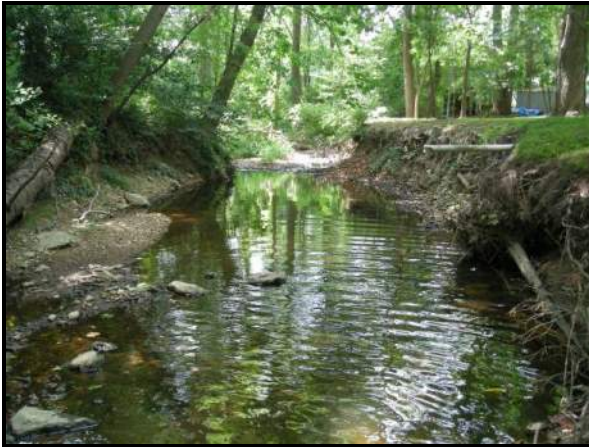
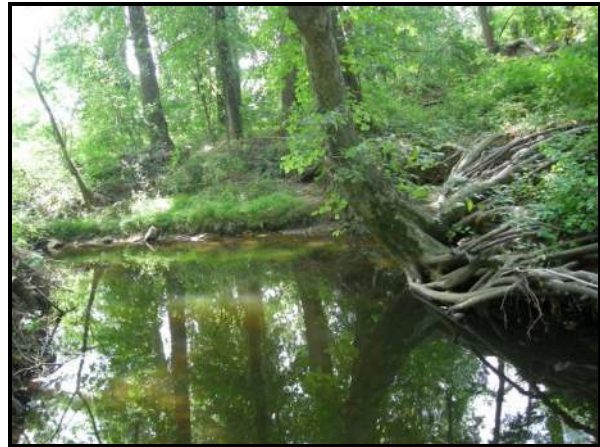
**Location:** First Church of Christ; from near the pond at Farrcroft Dr. to south of Daniels Run Elementary

**Site Score:** 40.7 – Very High

Steep eroded area upstream of Daniels Run Elementary School. Trees fallen in and undercut banks. Stream has more vegetation than DM-13, but steeper and more eroded.

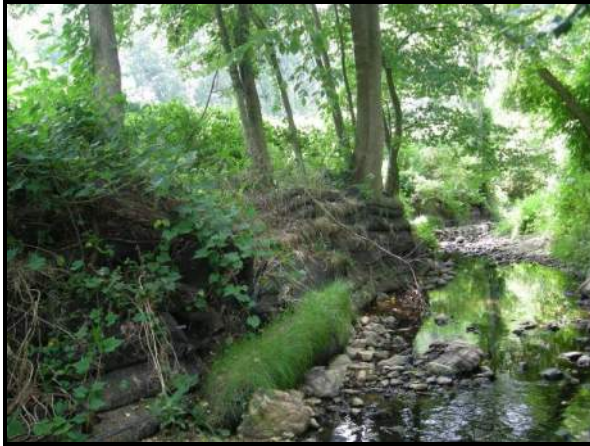
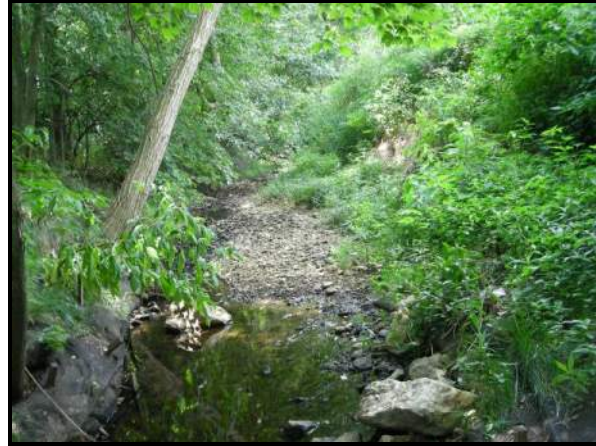
**Location:** Daniels Run Elementary; from the western edge of the Daniels Run Elementary property to 100 ft upstream of the bridge to Daniels Run Elementary

**Site Score:** 32.7 – High

Similar to DM 12, but revetment did not take as well. Slope less steep (40%). Matting holding back trees and only about 50% successful reseeding.

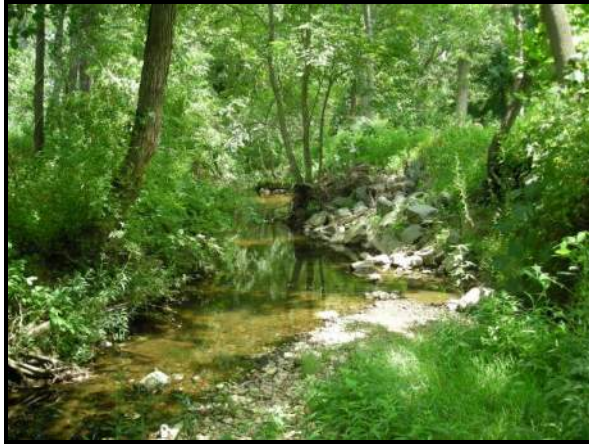
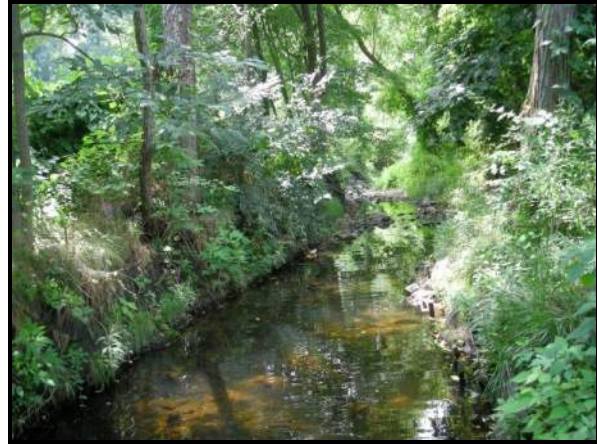
**Location:** Daniels Run Elementary; from upstream of the bridge to Daniels Run Elementary to 200 ft. upstream of the bridge between Colony Rd. and Daniels Run Elementary

**Site Score:** 31.9 – High

Highly vegetated banks, ranging from 60 to 90 degrees. Little bit of erosion. Matting visible, but doing well. Trees pushing at some matting/some trees falling into streambed.

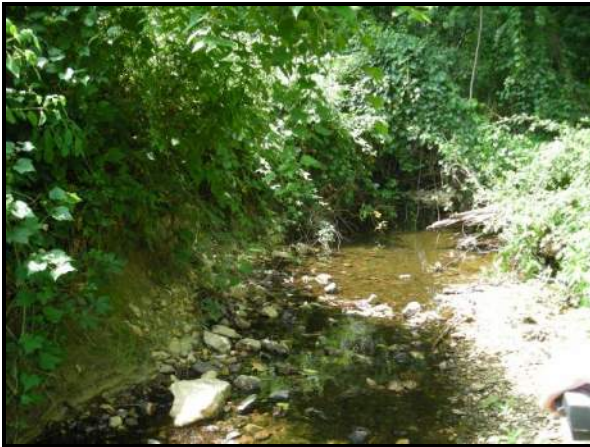
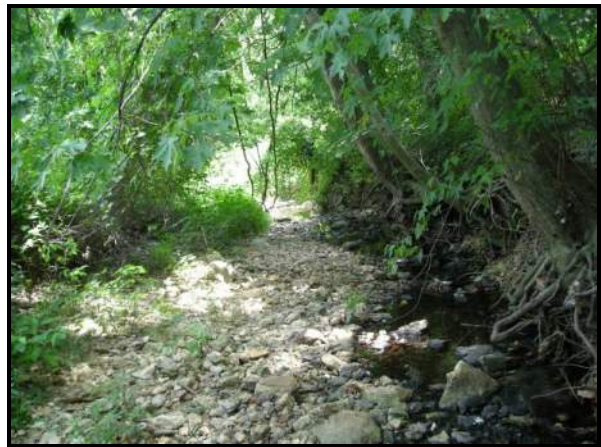
**Location:** Old Post Estates; from Anne Pl. to Tedrich Blvd.

**Site Score:** 40.9 – Very High

Deep channelized feature at north end of reach, then transitions to shallower. Very shrubby, densely vegetated area. High, steep banks. Slightly eroded banks.

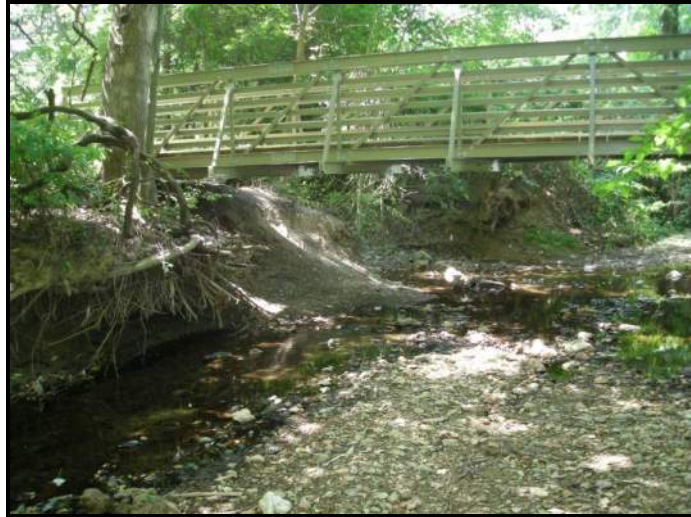
**Location:** Old Post Estates; around the bridge at Tedrich Blvd.

**Site Score:** 44.8 – Very High

Area around bridge highly eroded and in poor shape.

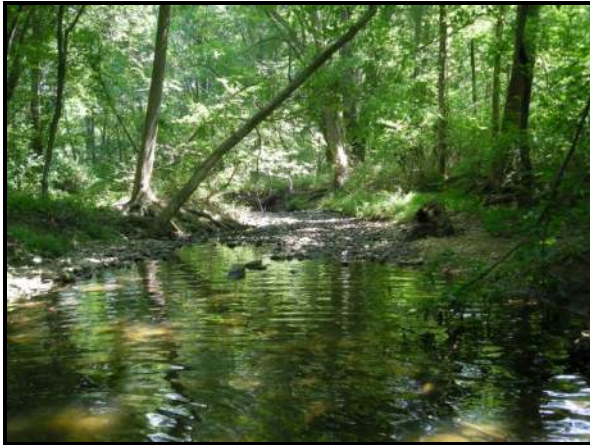
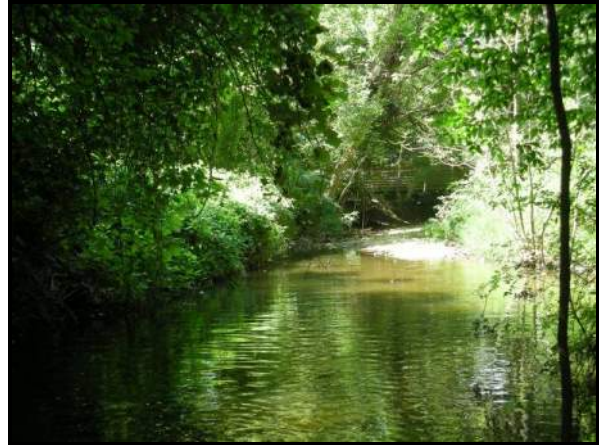
**Location:** West of Heritage Lane; from near the bridge at Tedrich Blvd. to 150 ft. upstream of Heritage Ln. Bridge

**Site Score:** 29.2 – Moderate

Nice shrubby area. Little bit of erosion, but not much. Small, shallow banks and 3 ft deep pool area.

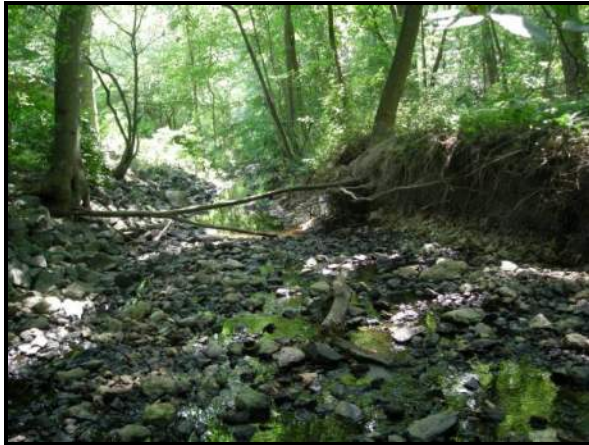
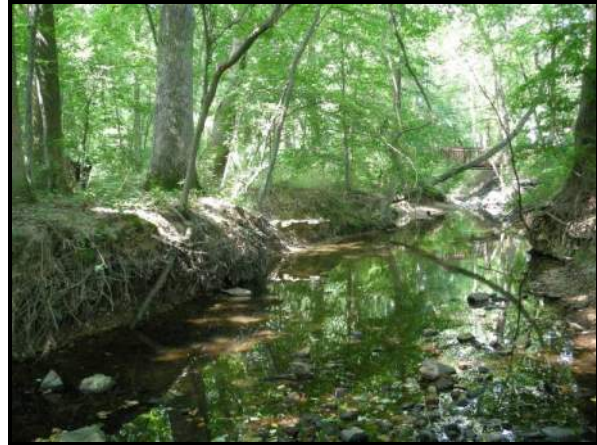
**Site Score:** 46.8 – Extreme

**Site Description:** Reach Length = 465 LF

Eroded banks; more like DM 5. Tall, steep banks, lots of exposed roots.

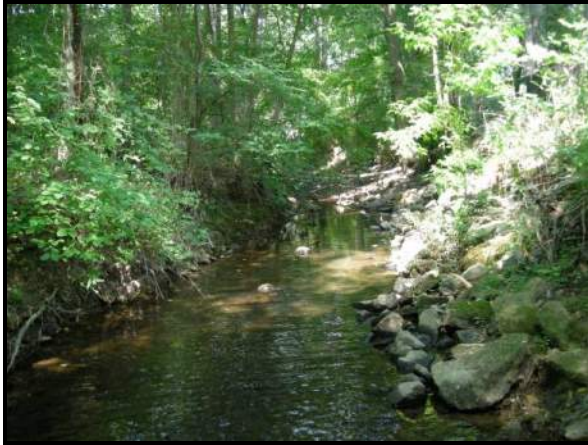
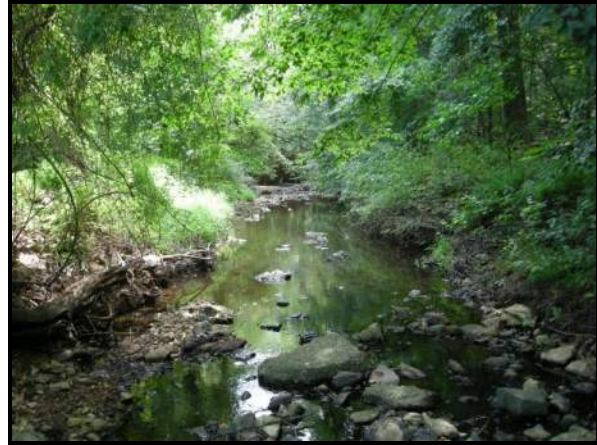
**Site Score:** 32.5 – High

**Site Description:** Reach Length = 123 LF

Shallow slopes, lots of cobble. Some exposed saprolite. Lots of vegetation, but all herby/shrubby- very few trees. Some armored slopes, but not common.

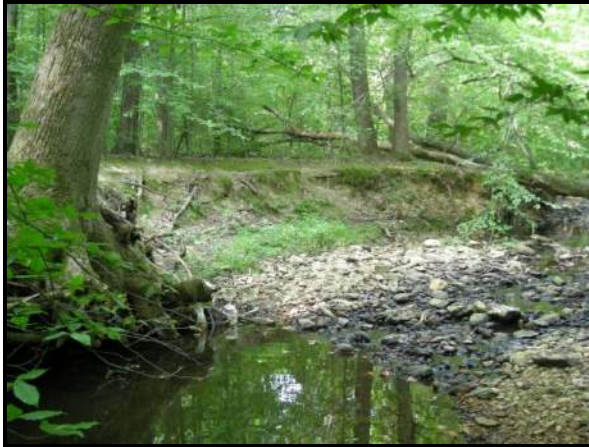
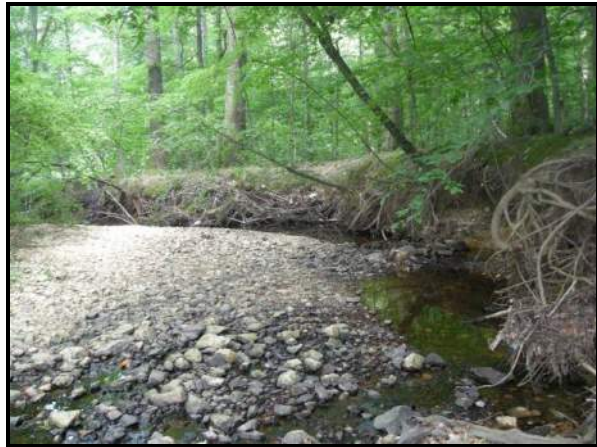
**Site Score:** 44.6 – Very High

**Site Description:** Reach Length = 1958 LF

100 feet upstream of bridge at edge of Daniels Run Park, obvious stabilization ends. Lots of fallen trees, mostly steep banks. Small cobble.

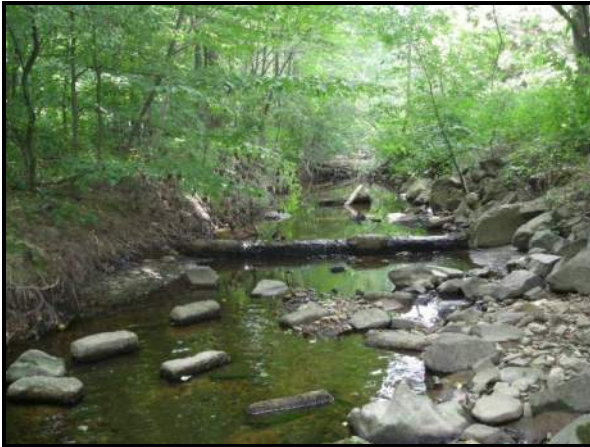
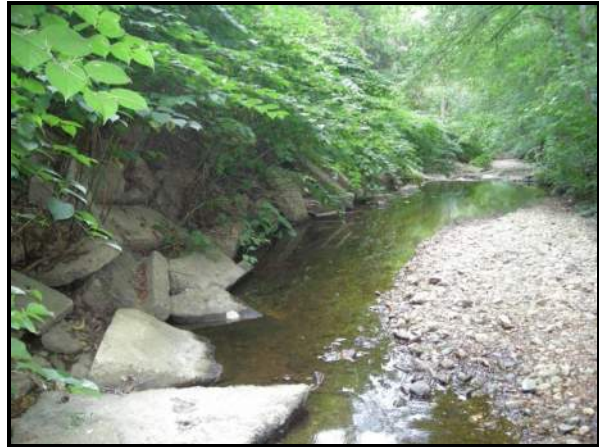
**Site Score:** 33.1 – High

**Site Description:** Reach Length = 423 LF

Previously restored area. Lots of concrete in the channel, non-armored side eroded.

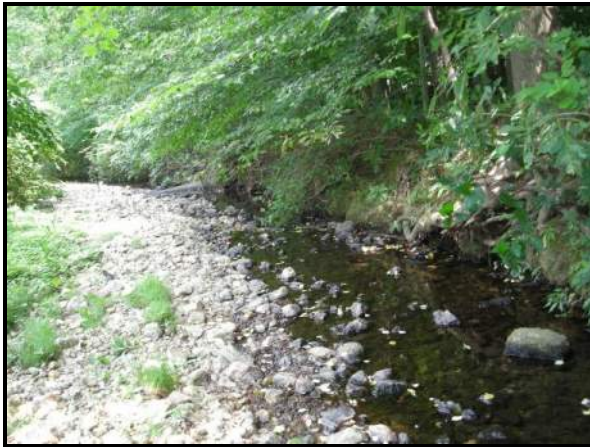
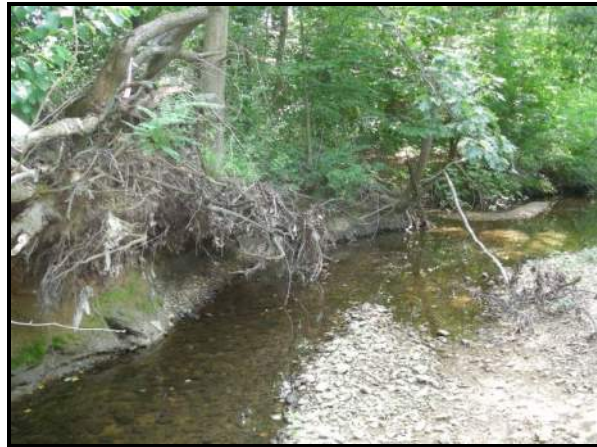
**Site Score:** 35.6 – High

**Site Description:** Reach Length = 415 LF

Erosion and scour downstream of St. Andrews Dr. Some right bank erosion, a lot of vegetation. Tight channel.

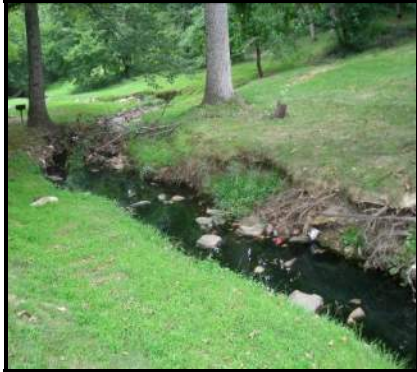
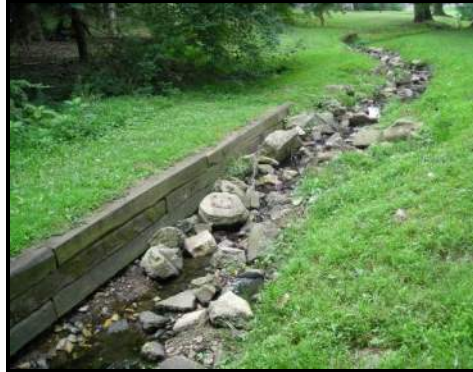
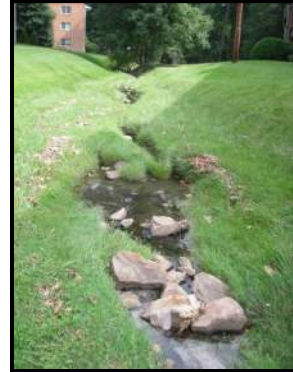
**Site Score:** 32.2 – High

**Site Description:** Reach Length = 491 LF

Stream channel filled with boulders and cobble. Timber used to protect some banks. Two sections show evidence of erosion- one looks like the timber was removed and vegetation is reestablishing.

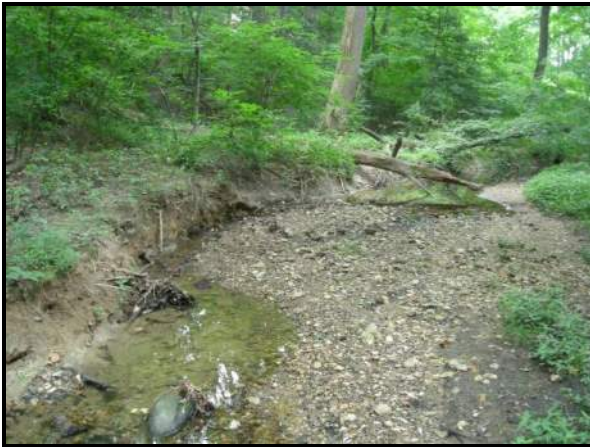
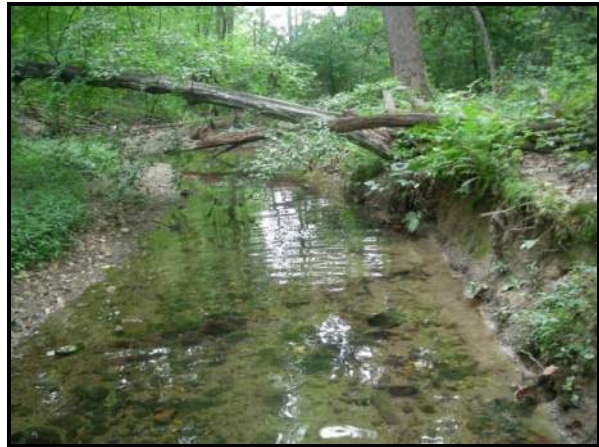
**Site Score:** 35.8 – High

**Site Description:** Reach Length = 453 LF

Banks become defined from area D-1; wide channel more erosion and fallen trees. Only left downstream bank eroded; right bank a gradual slope.

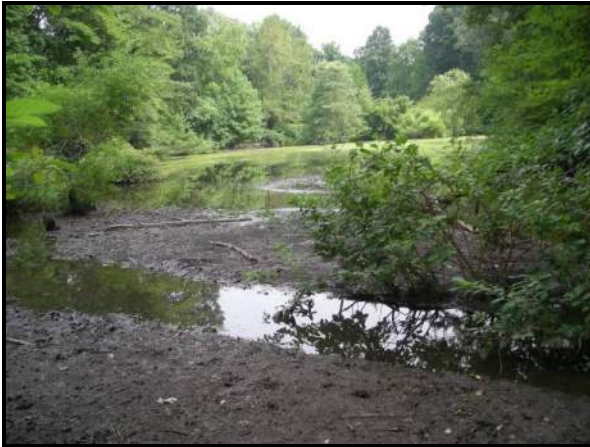
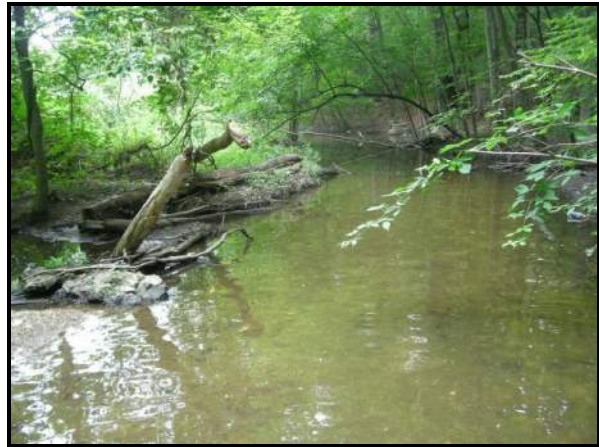
**Site Score:** 28.0 – Moderate

**Site Description:** Reach Length = 178 LF

Low-lying floodplain area- transition from pond to defined stream banks. Very muddy and wide.

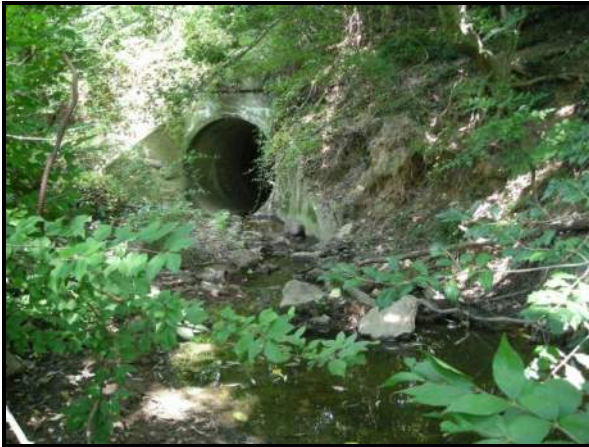
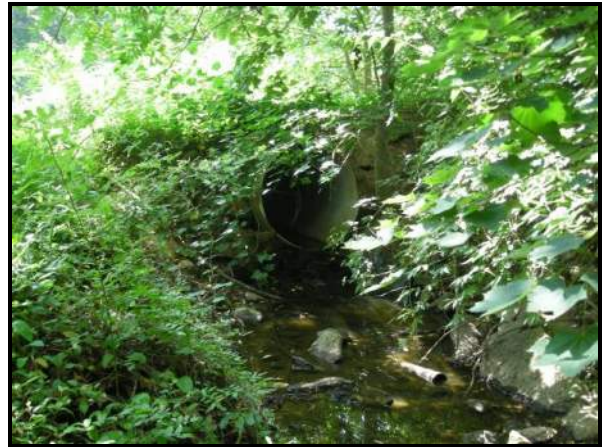
**Site Score:** 41.4 – Very High

**Site Description:** Reach Length = 107 LF

Section of stream between two culverts, one under Ashby Rd. and the other to the pond. Ivy with some shrubs, lots of concrete debris and rebar. Fallen trees and some steep, exposed banks.

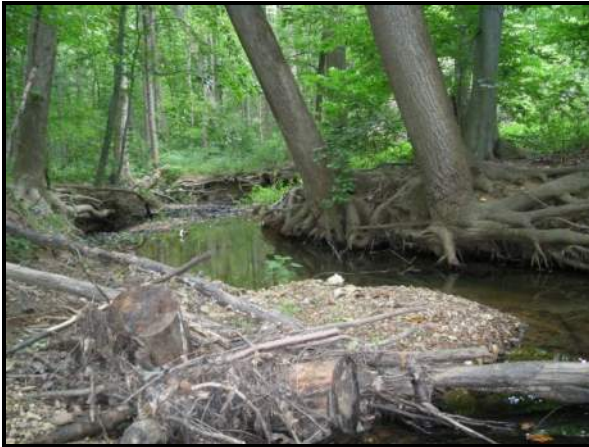
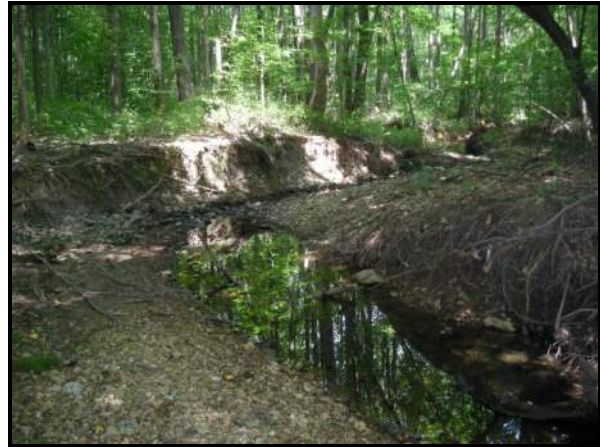
**Site Score:** 47.0 – Extreme

**Site Description:** Reach Length = 653 LF

Sinuuous area with severely eroded outside bends; some sediment deposition on inside bends. Mostly steep or undercut banks with trees falling in. Coarse gravel, cobble. Fallen trees.

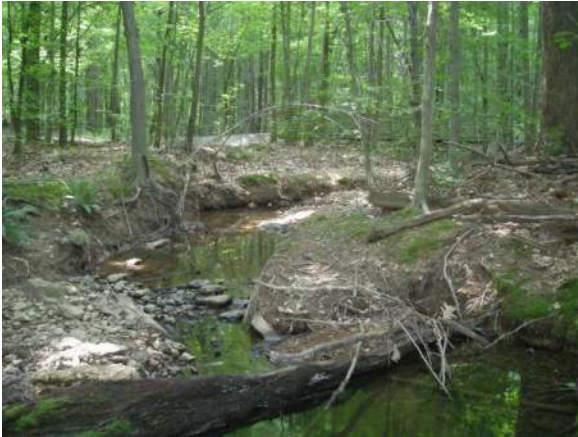
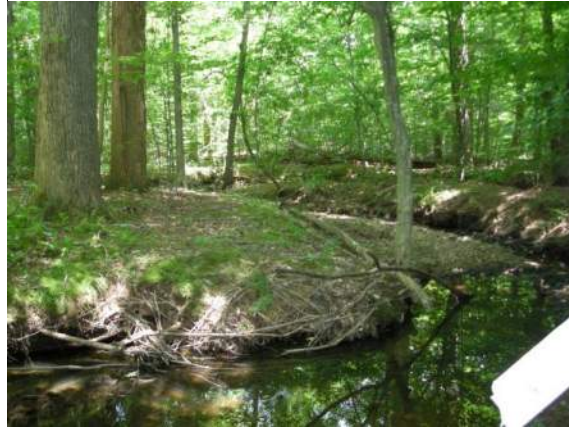
**Site Score:** 39.5 – High

**Site Description:** Reach Length = 331 LF

Less curvy section between two sinuous sections of stream. Banks shallower and less eroded. Mossy area, not much groundcover other than trees.

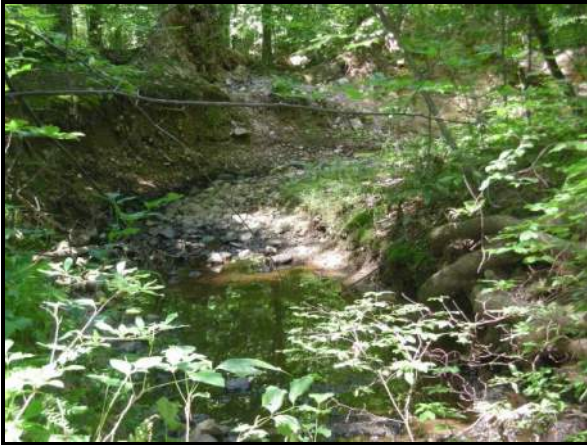
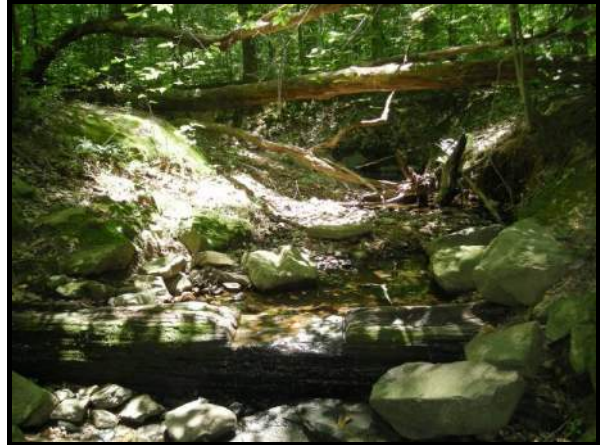
**Site Score:** 48.5 – Extreme

**Site Description:** Reach Length = 569 LF

Extremely sinuous section of stream. Lots of fallen debris and eroded areas. Banks tall and steep, confluence incised. Lots of cobble.
